**CHAMPIONS QUARRY - MATERIAL
ASSESSMENT OF PROPOSED
EXPANSION AREA.**

Reaville Farm Pty Ltd
Tucki Tucki

GEOTALST01597AB-AE
15 February 2007

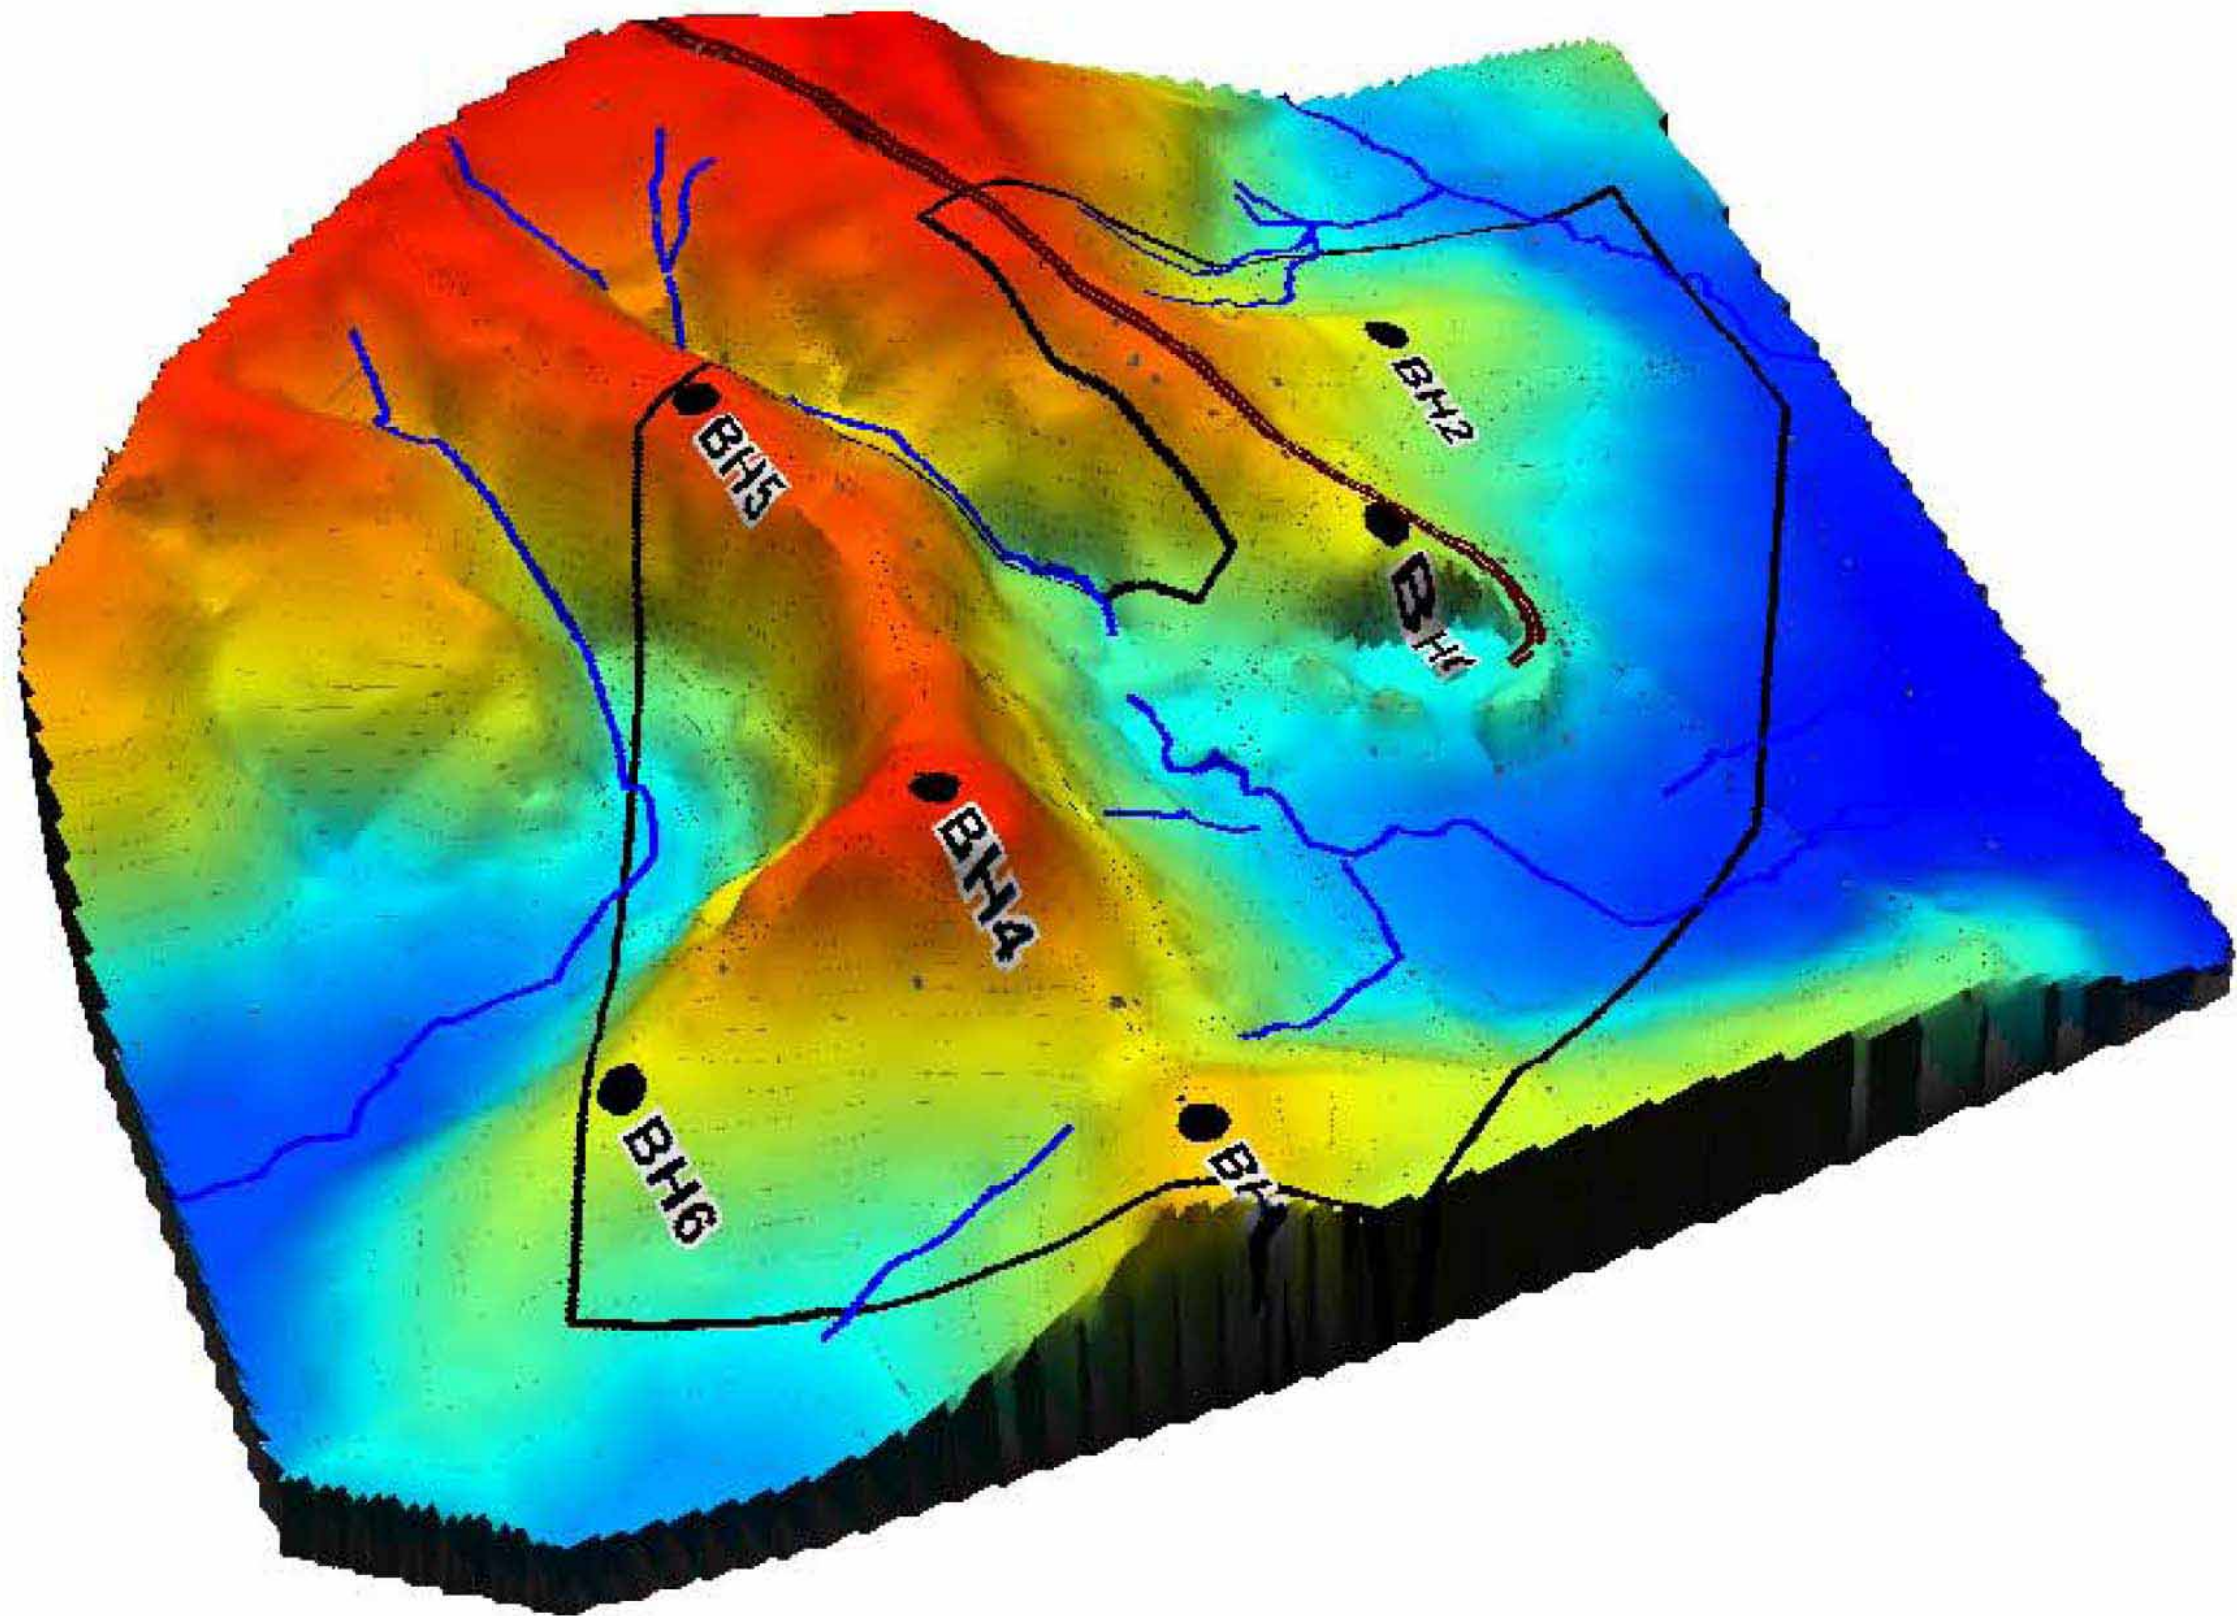
Figure 2: Enhanced colour contour plan of site.

Regionally the site is situated within undulating hills which are separated by relatively flat floored valleys that are in part flood prone. At the existing quarry site the ground slopes moderately to the north east and forms a north east trending local drainage catchments that flows eventually to the south east towards Tucki Swamp. The proposed expansion area comprises two ridge lines and the land north of them and between the ridges. The proposed base of the quarry is anticipated to be no lower than 10m AHD. The existing quarry face crest is located at approximately 25m AHD, and the floor of the existing quarry is located at approximately 16m AHD. Vegetation across the proposed expansion includes improved pastures and sparse tree cover. Figure 1 presents the site contour plan and borehole locations, whilst Figure 2 presents the contour data shaded as a 3D image.

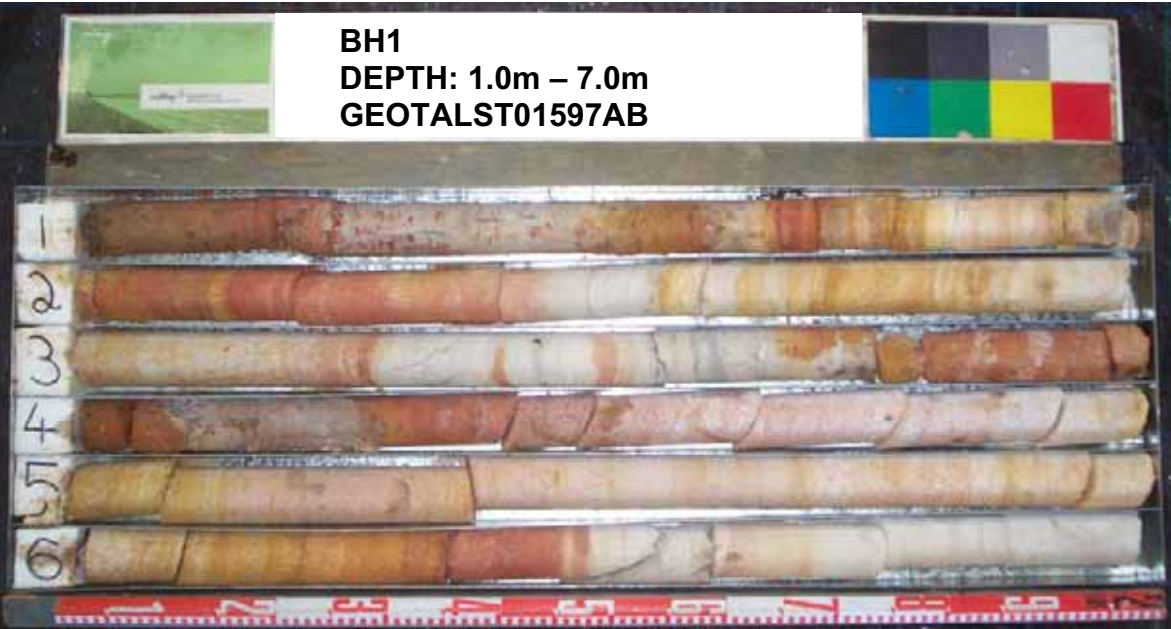
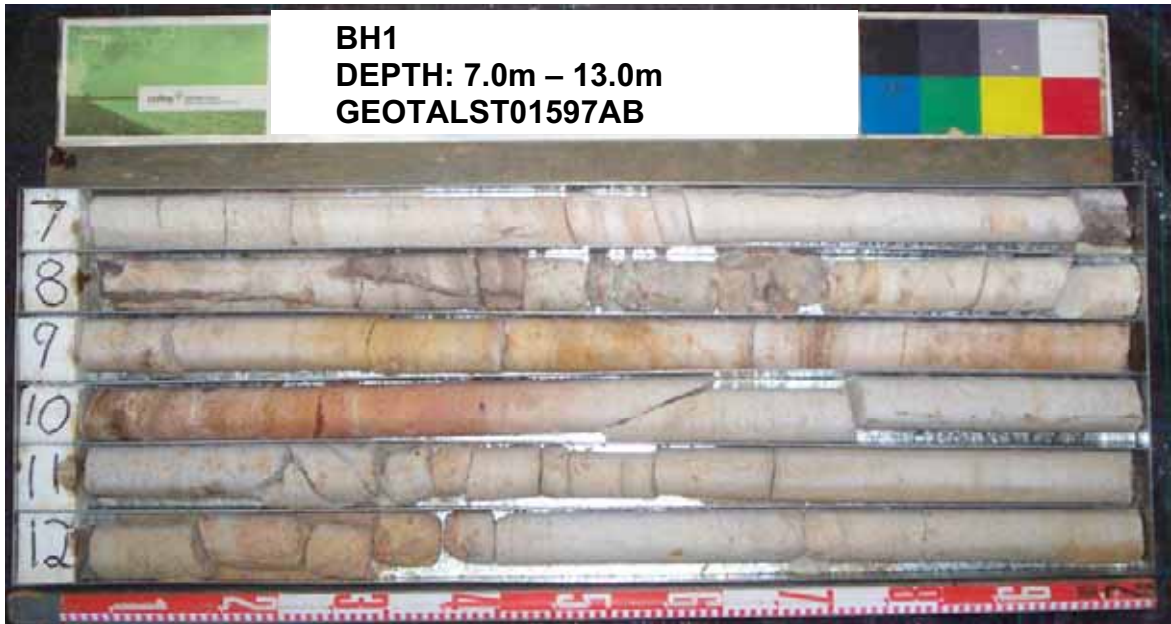
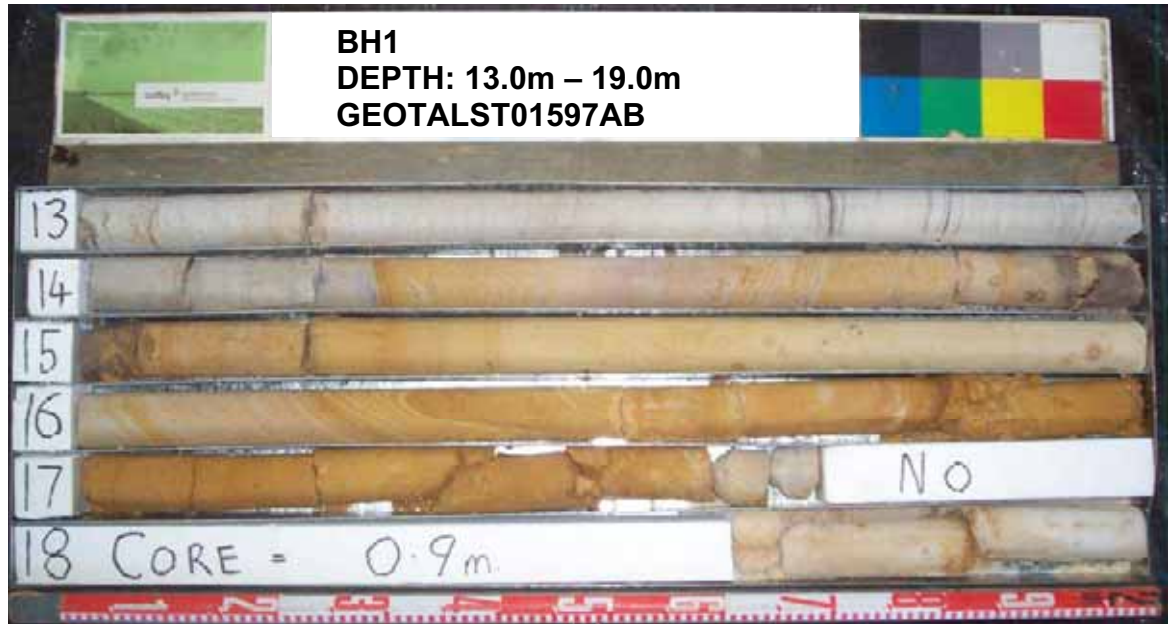
SPECIALISTS MANAGING THE EARTH	client:	JEFF CHAMPION	
	approved	TGN		project:	MATERIAL ASSESSMENT CHAMPIONS QUARRY	
	date	21/1/08		title:	RECOVERED CORE SAMPLES BOREHOLE 1	
	scale	NTS		project no:	GEOTALST01597AB	figure no: FIGURE 3
	original size	A3

Figures 3 to 10: Core Photographs

The stratigraphy interpreted from the boreholes is summarised in Table 1, Core photographs are presented as Figures 3 to 10 and the stratigraphy is shown graphically in Figures 11 to 15.
