RICHMOND QUARRY

**Annual Review 2018
Calendar Year**

IMS-COMP-G-0875-RQ

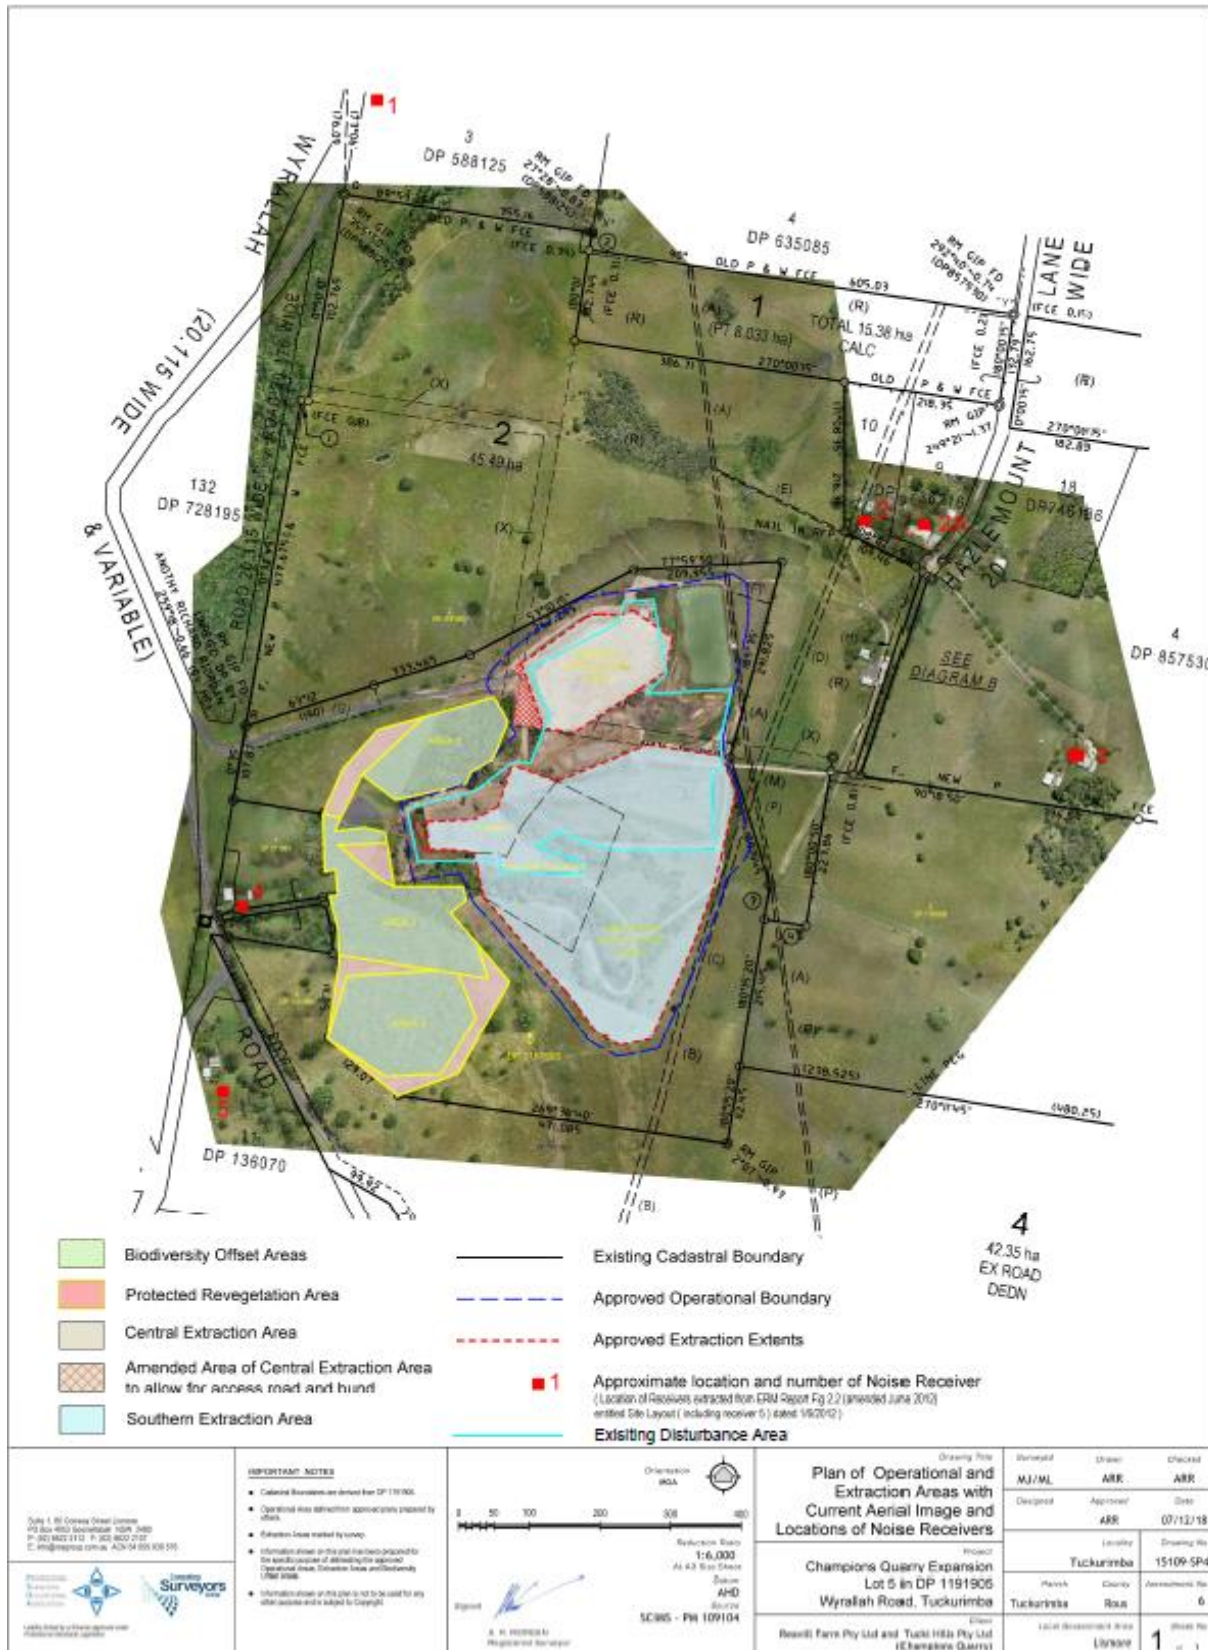
Figure 3: Disturbance Footprint 2018

The current Quarry disturbance footprint is identified in Figure 3 of Appendix A.

Over the course of the 2018 calendar year quarry operations continued to predominantly occur within Progression 1 of the Southern Extraction Area. The Central Extraction Area is used as a sale and stockpile area for product loading prior to transport. The operational boundaries and disturbance footprint is shown in Appendix A, Figure 3.

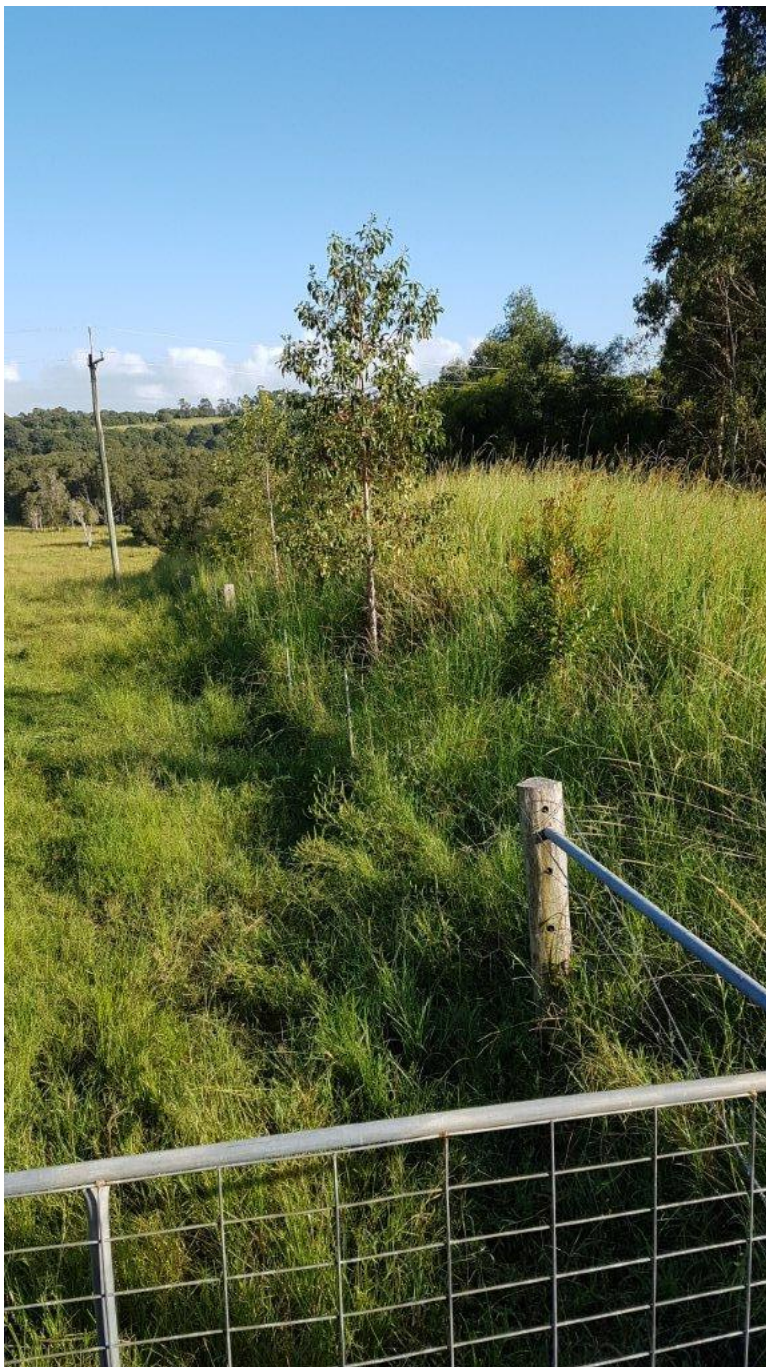
BUND A

View of Bund A from the eastern end, trees planted to the north of the Bund and a single row of non-koala habitat trees on the south-western side of the Bund. Photo March 2018.

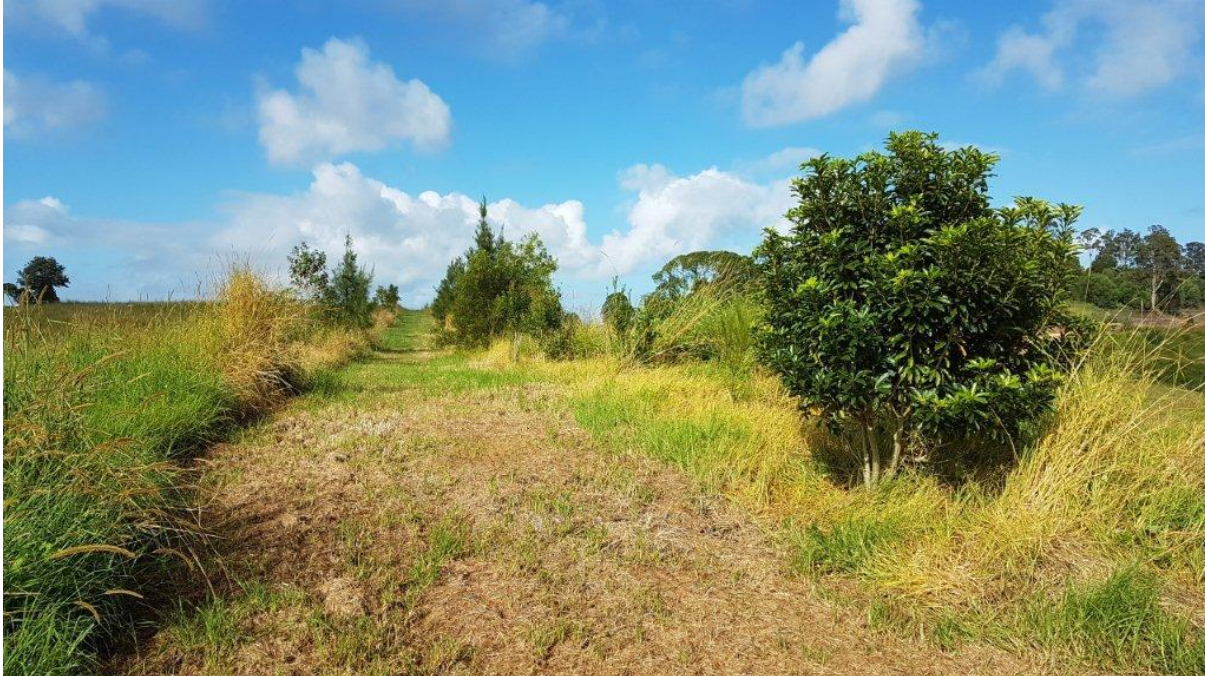
BUND B

Bund B – Low earth mound 10 metres wide. Established and grassed and planted with 2 rows of non-koala habitat trees/shrubs. Photo March 2018.

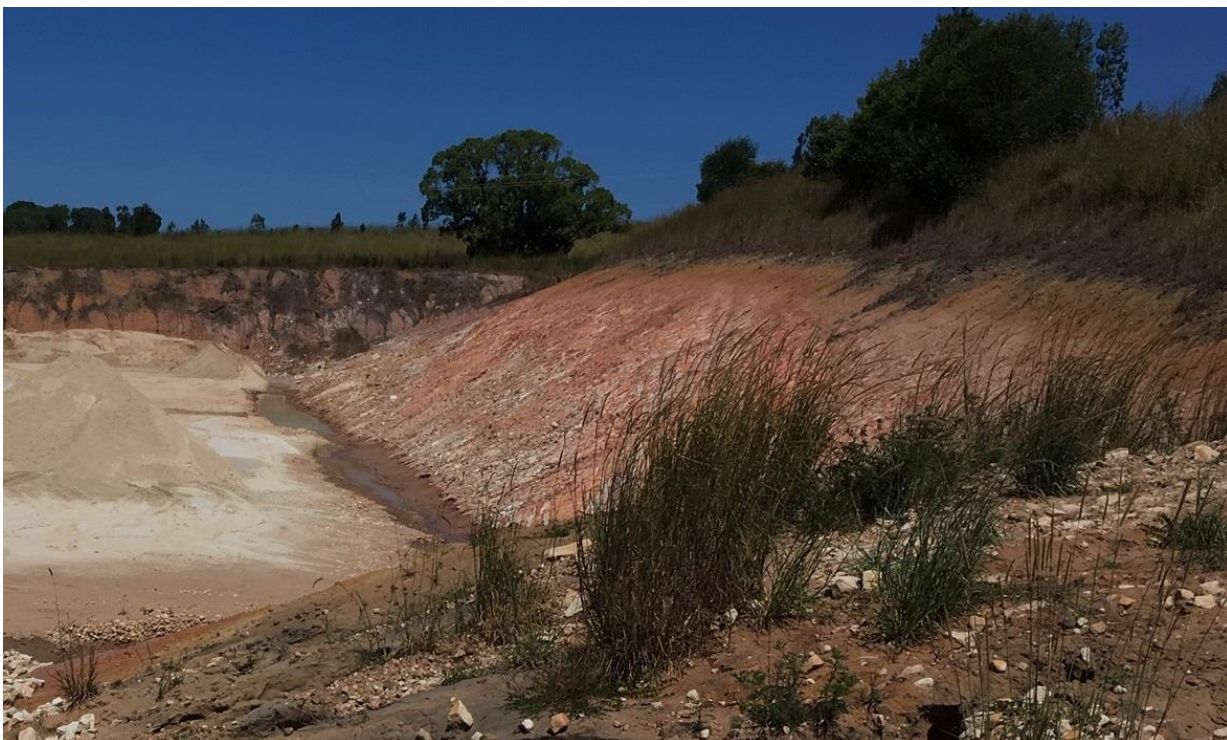
BUND C

Earth bund surrounding the Sand Washing Plant approx. 15 metres wide. Photo January 2019.

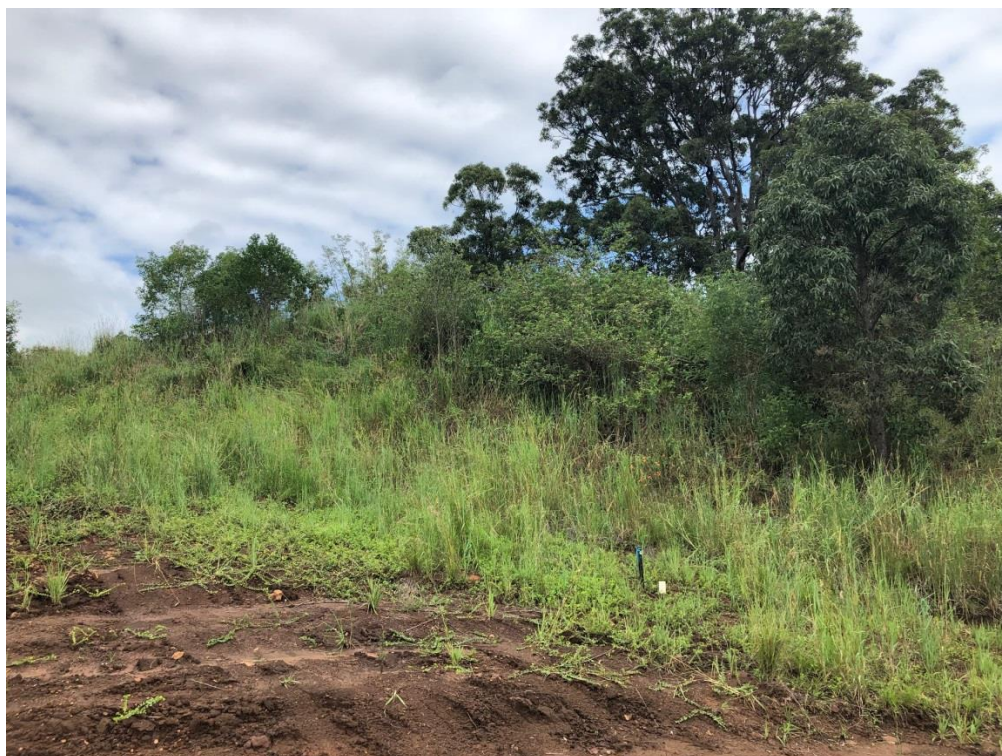
BUND D

10 metre wide bund. Established and grassed. Photo March 2019.

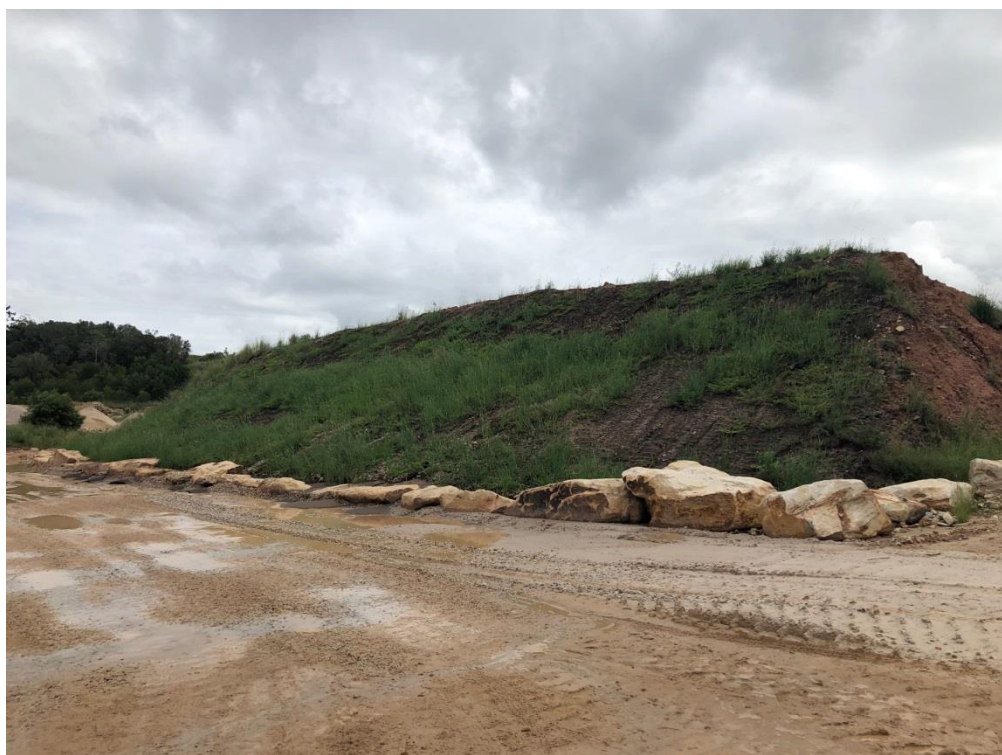
BUND E

Low sacrificial bund 10 metres wide. Established and grassed. Photo March 2019.

- Condition 18(3) Bund E was grassed and planted with native endemic shrubs and trees.
- Condition 14A(3) The construction of a 1 megalitre (ML) sedimentation pond prior to the operation of the sand washing plant. For operational reasons, it is planned that two sedimentation ponds were constructed on-site in 2018 prior to the operation of the sand washing plant.

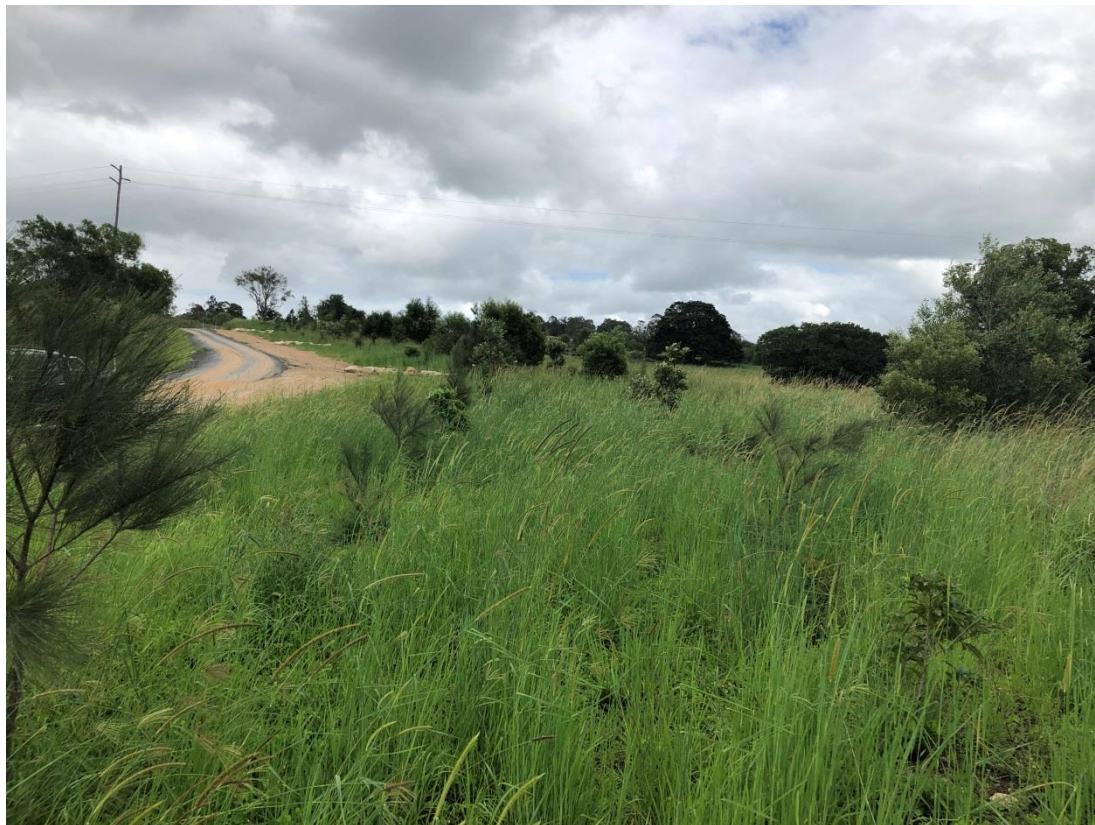
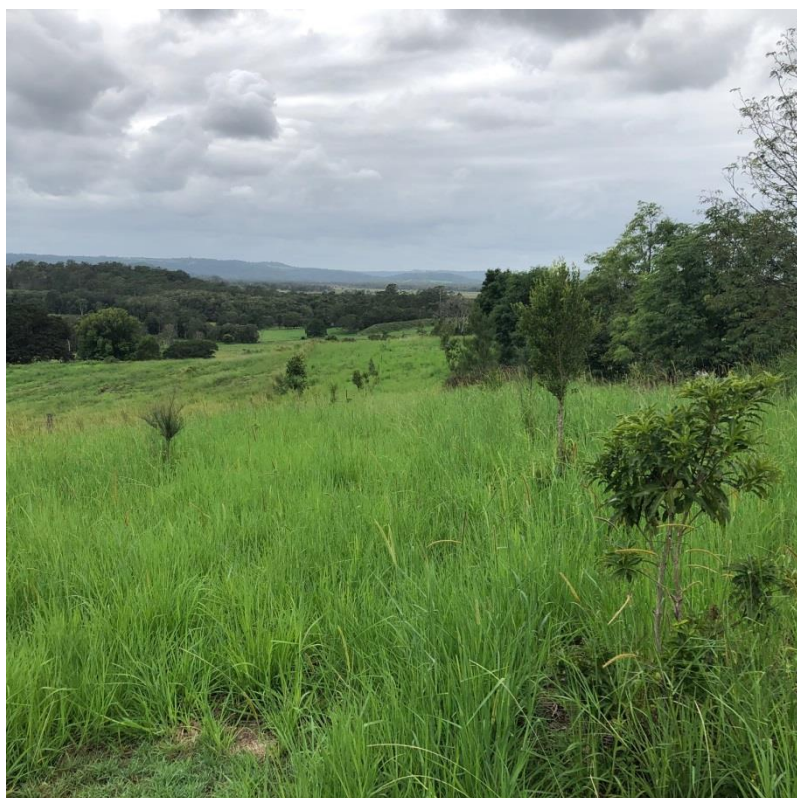
AREA TO THE NORTH OF THE MAIN ACCESS ROAD

Established, grassed and planted with 2 rows of non-koala habitat trees/shrubs. Photo March 2019.

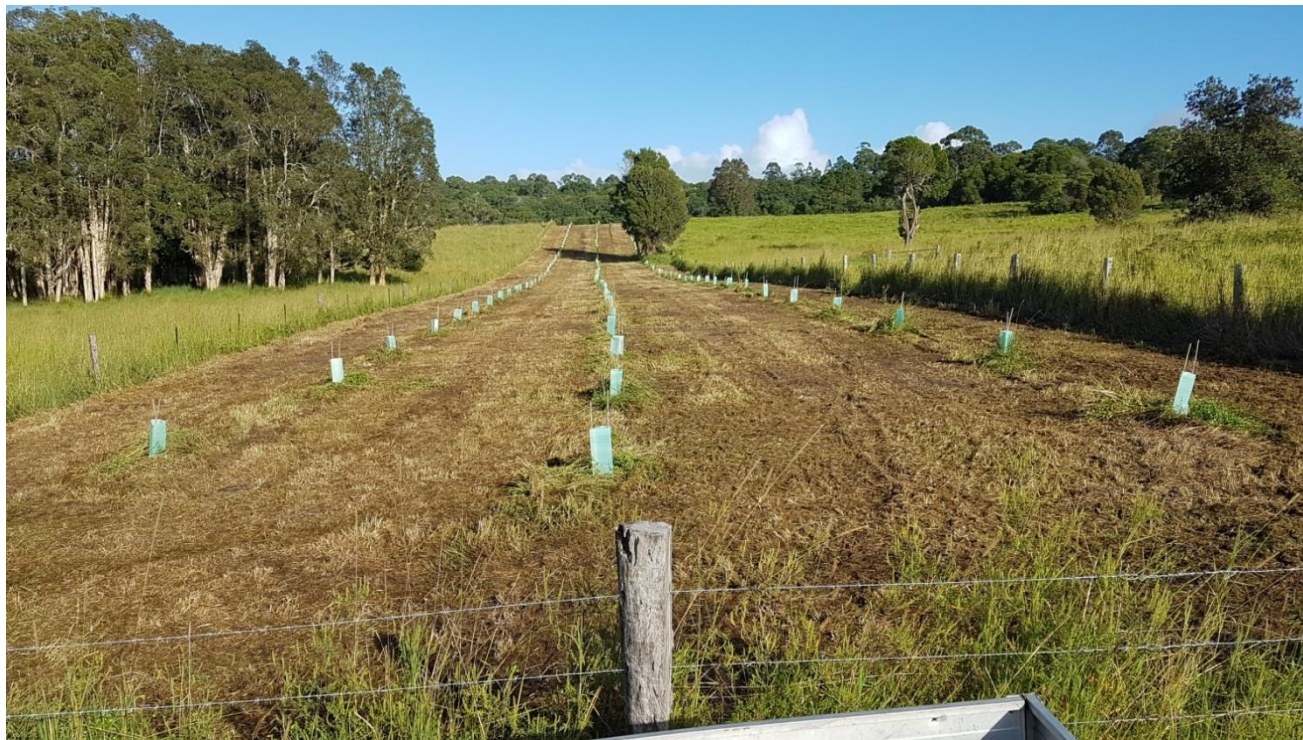
KOALA HABITAT PLANTING AREA

Established, grassed and planted with 3 rows of koala habitat trees/shrubs. This area was planted in September 2017. Photo March 2018.

The planting of the Koala Habitat Planting Area required by Condition 19(3) was completed in September 2017. The site was planted with 3 rows of koala habitat trees/shrubs, with a photo of the area provided in Appendix F.
