RICHMOND QUARRY

**Annual Review 2020
Calendar Year**

IMS-COMP-G-0875-RQ

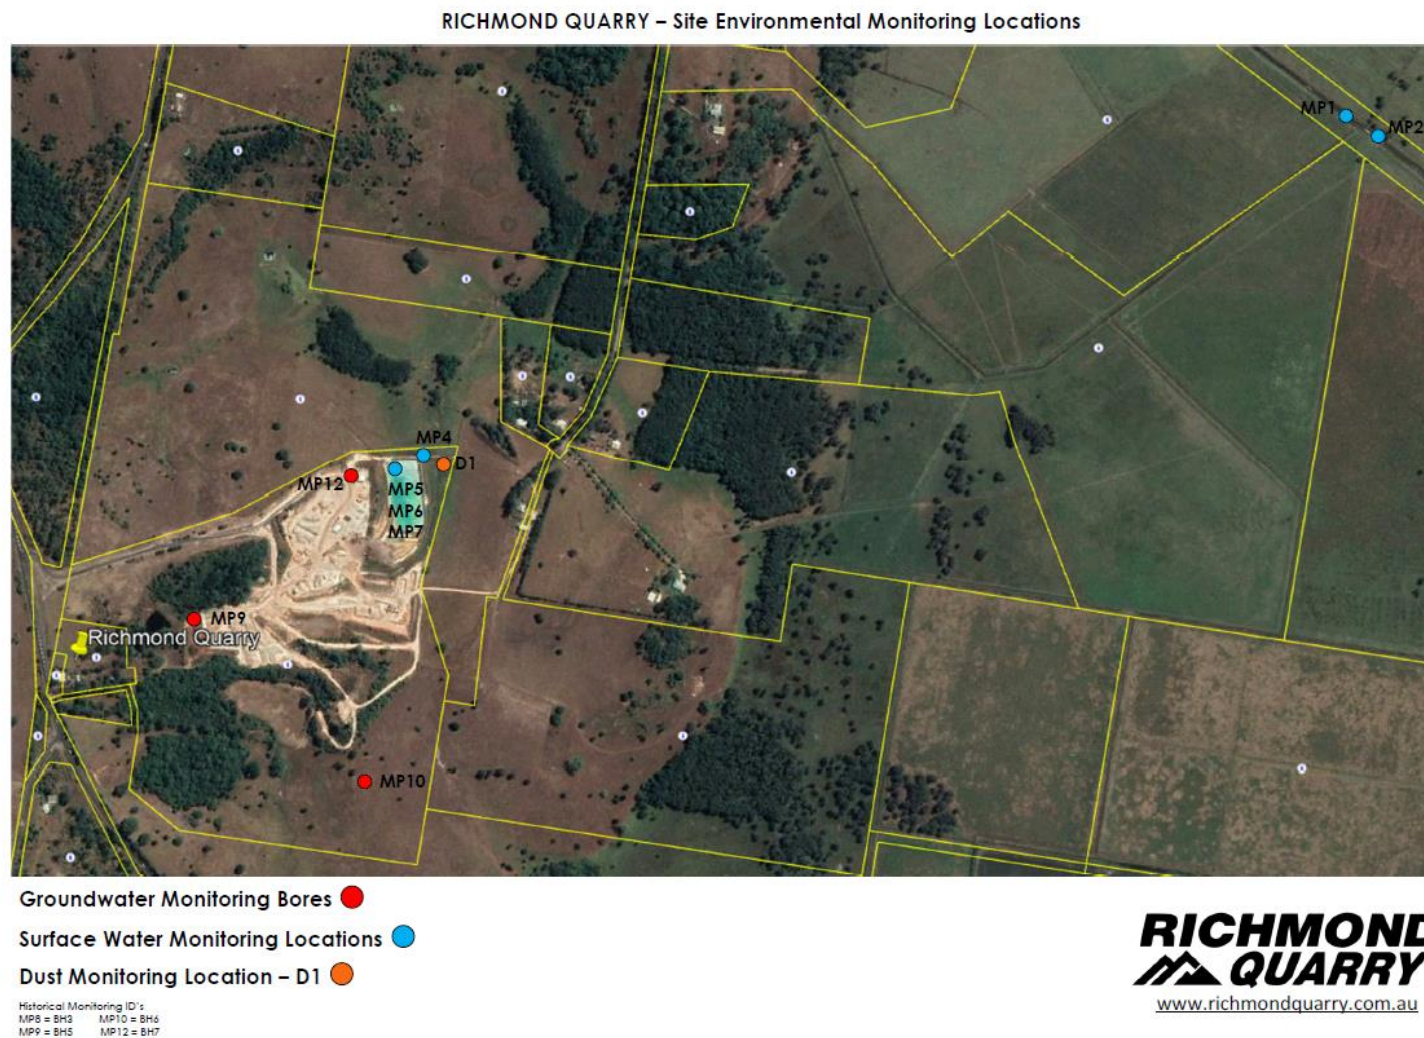
Figure 4: Environmental Monitoring Locations

The environmental monitoring program for the site includes surface water, groundwater and dust monitoring as detailed in Figure 4 of Appendix A.

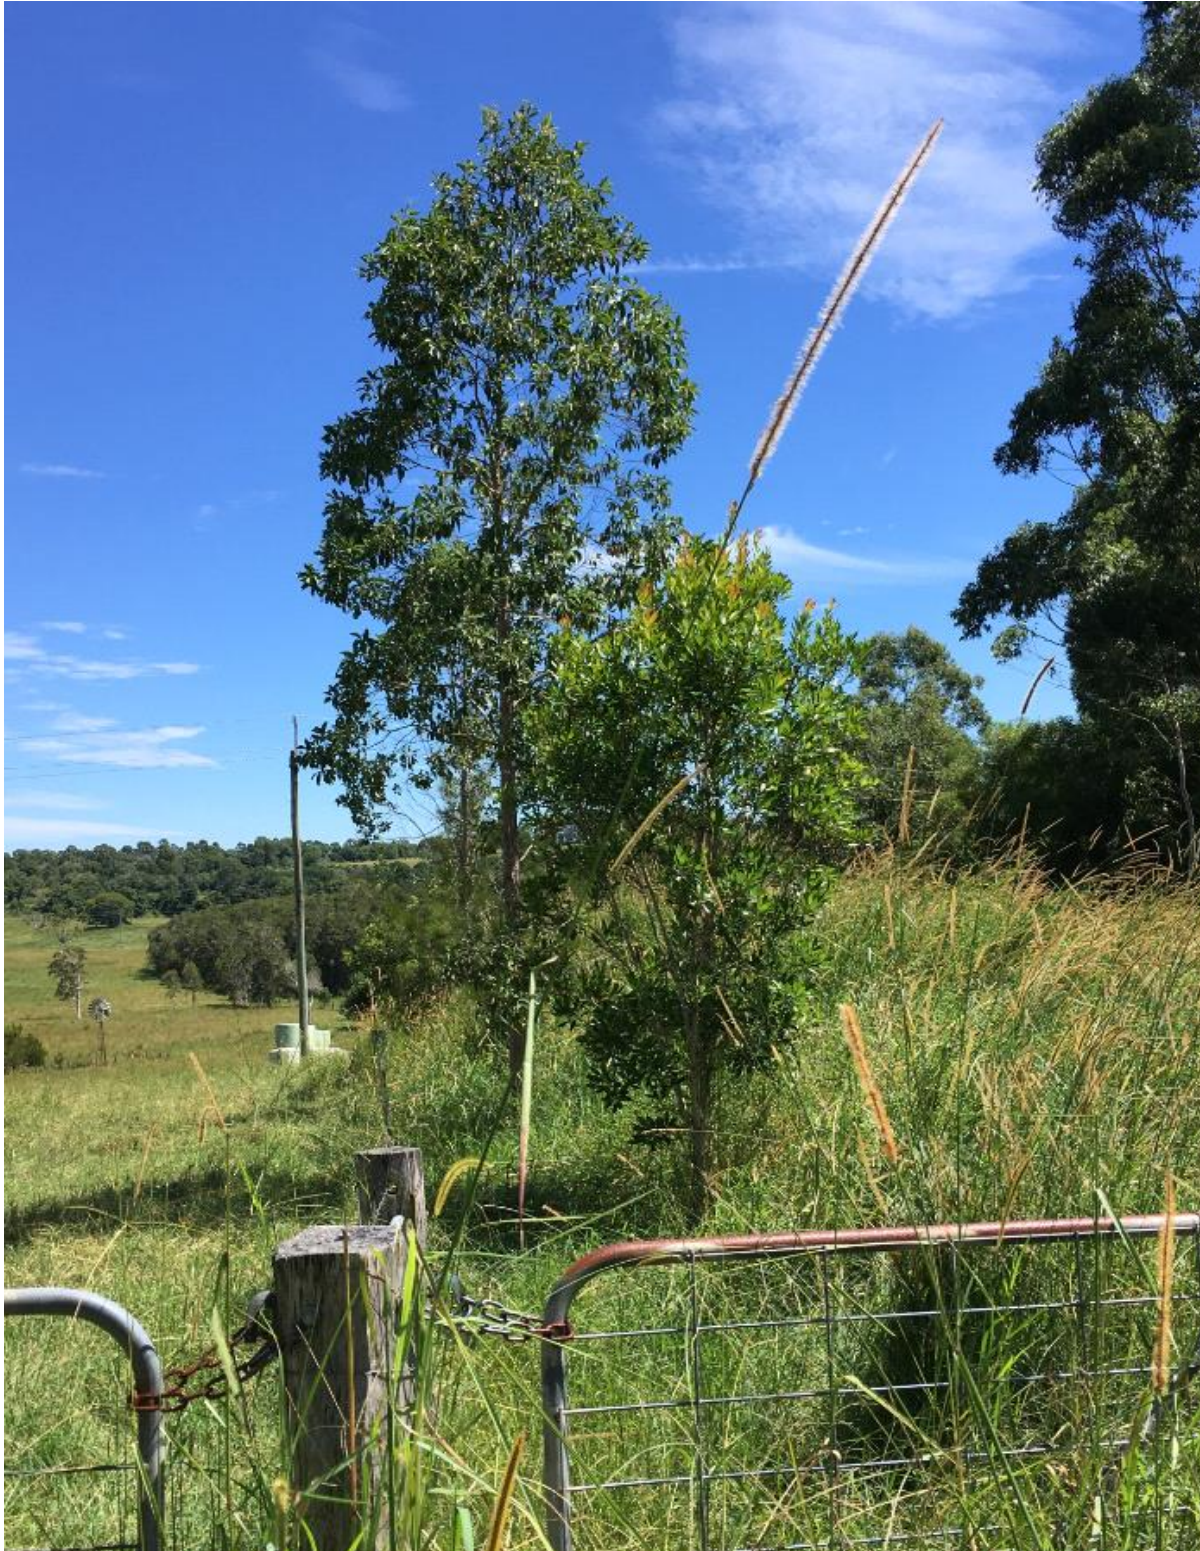
BUND A

View of Bund A from the eastern end, trees planted to the north of the Bund and a single row of non-koala habitat trees on the south-western side of the Bund. Photo March 2021.

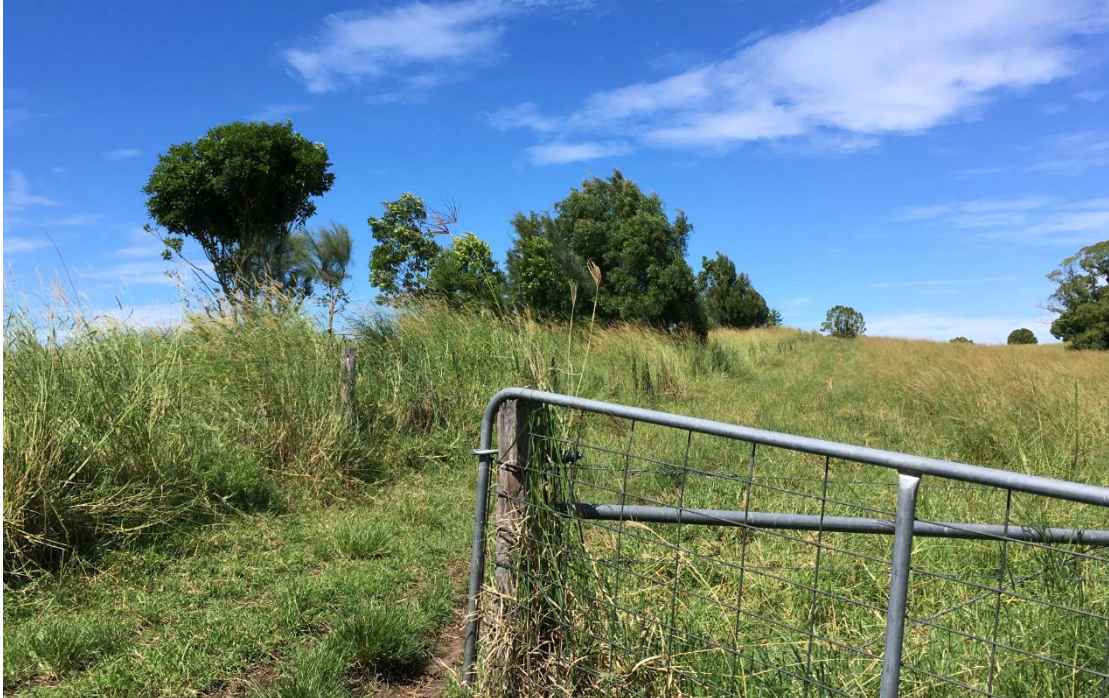
BUND B

Bund B – Low earth mound 10 metres wide. Established and grassed and planted with 2 rows of non-koala habitat trees/shrubs. Photo March 2021.

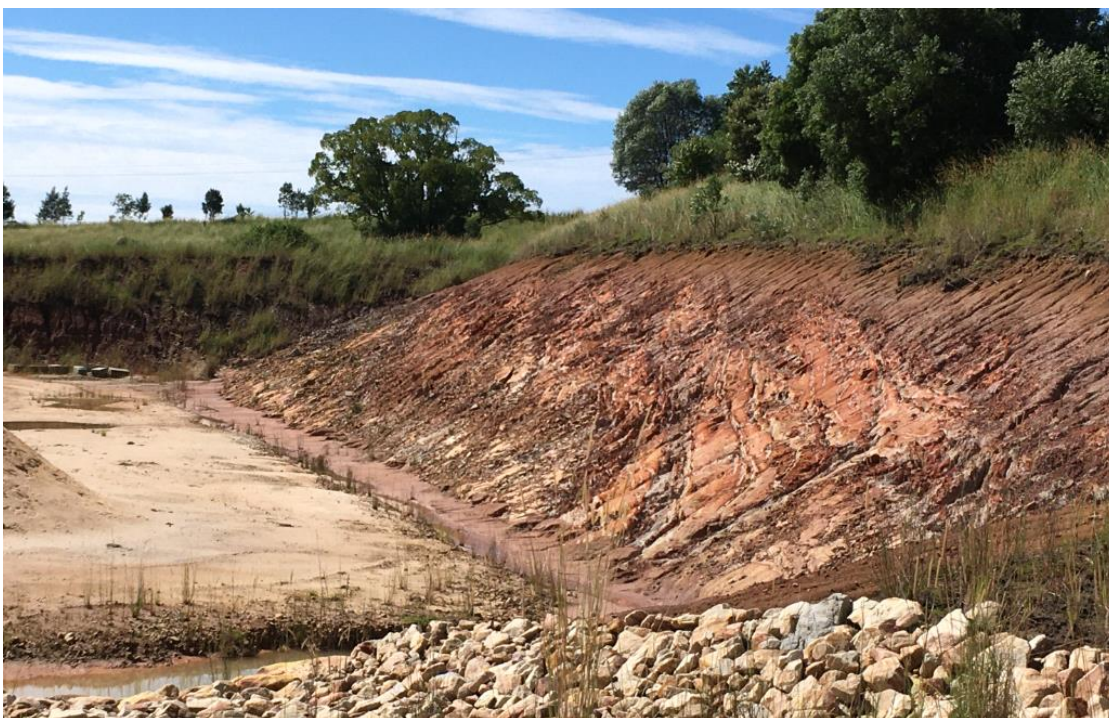
BUND C

Earth bund surrounding the Sand Washing Plant approx. 15 metres wide. Photo March 2020.

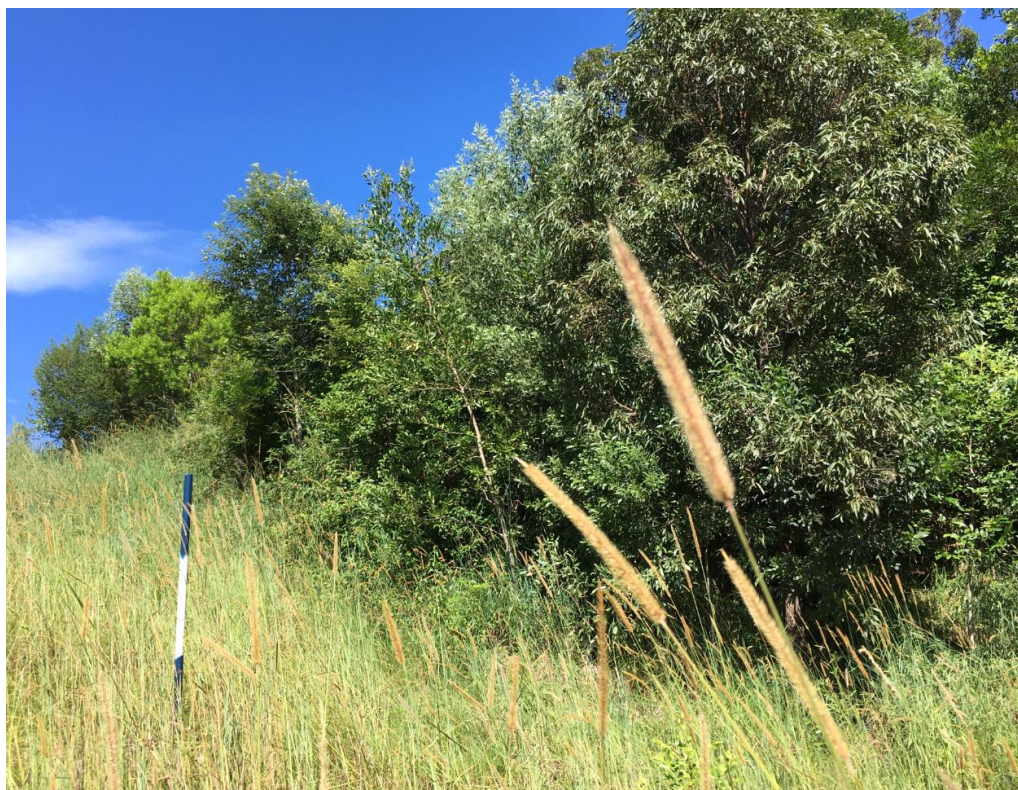
BUND D

10 metre wide bund. Established and grassed. Photo March 2021.

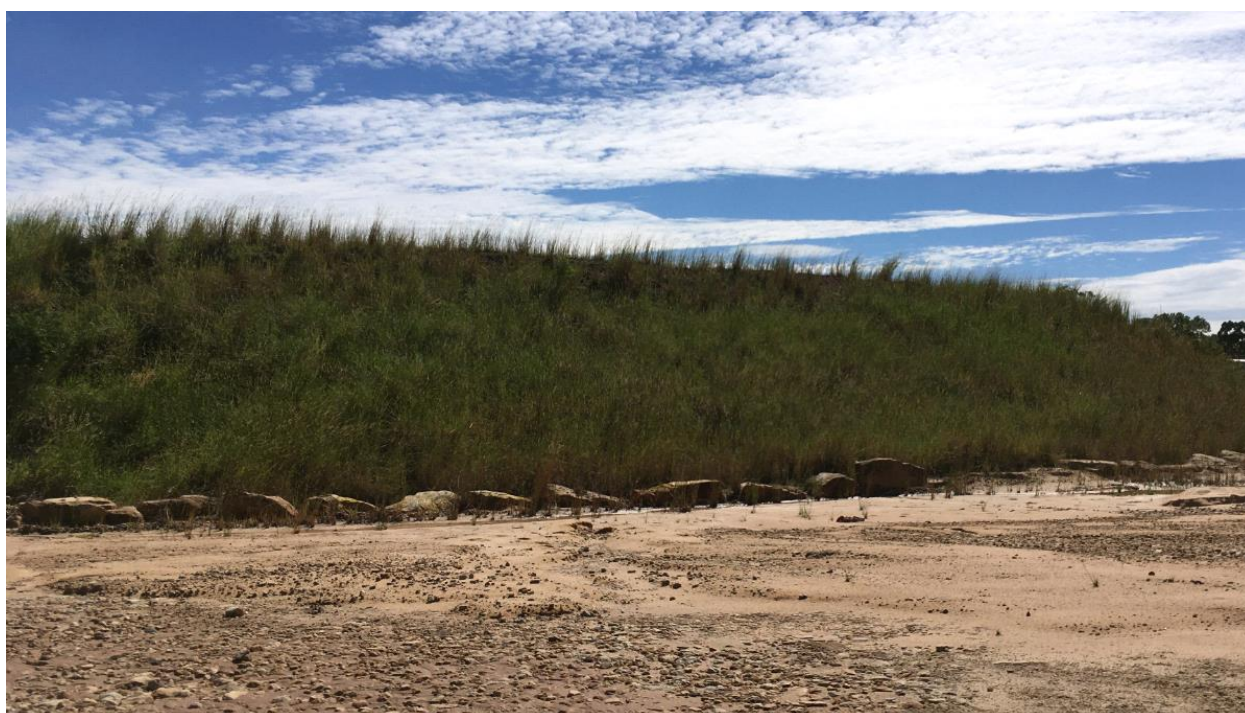
BUND E

Low sacrificial bund 10 metres wide. Established and grassed. Photo March 2021.

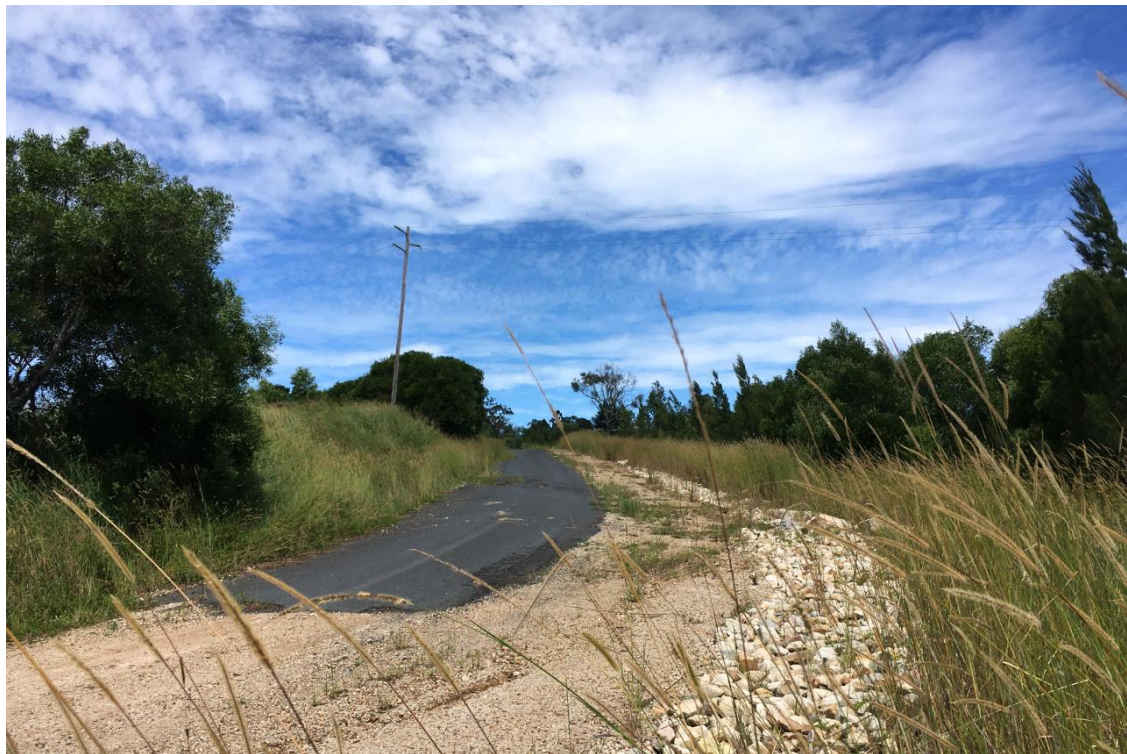
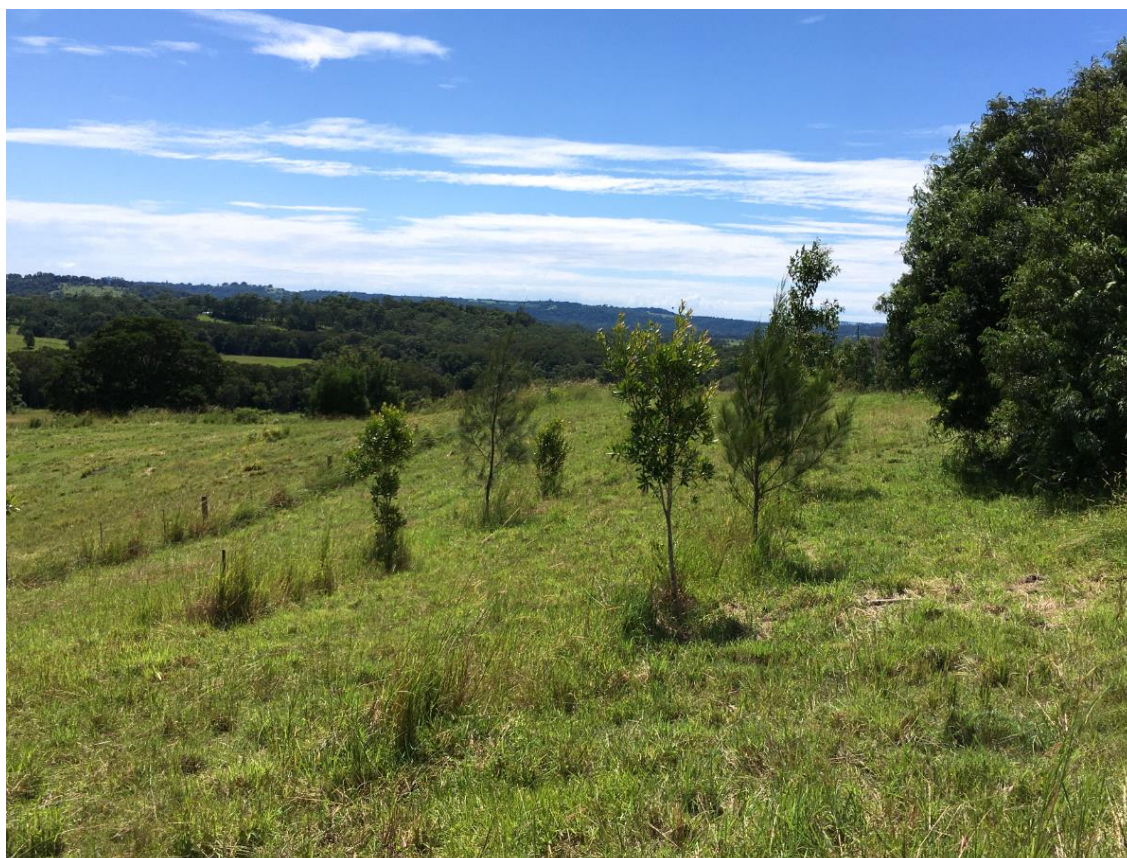
AREA TO THE NORTH OF THE MAIN ACCESS ROAD

Established, grassed and planted with 2 rows of non-koala habitat trees/shrubs. Photo March 2021.
