RICHMOND QUARRY

**Annual Review 2024
Calendar Year**

IMS-COMP-G-0875-RQ

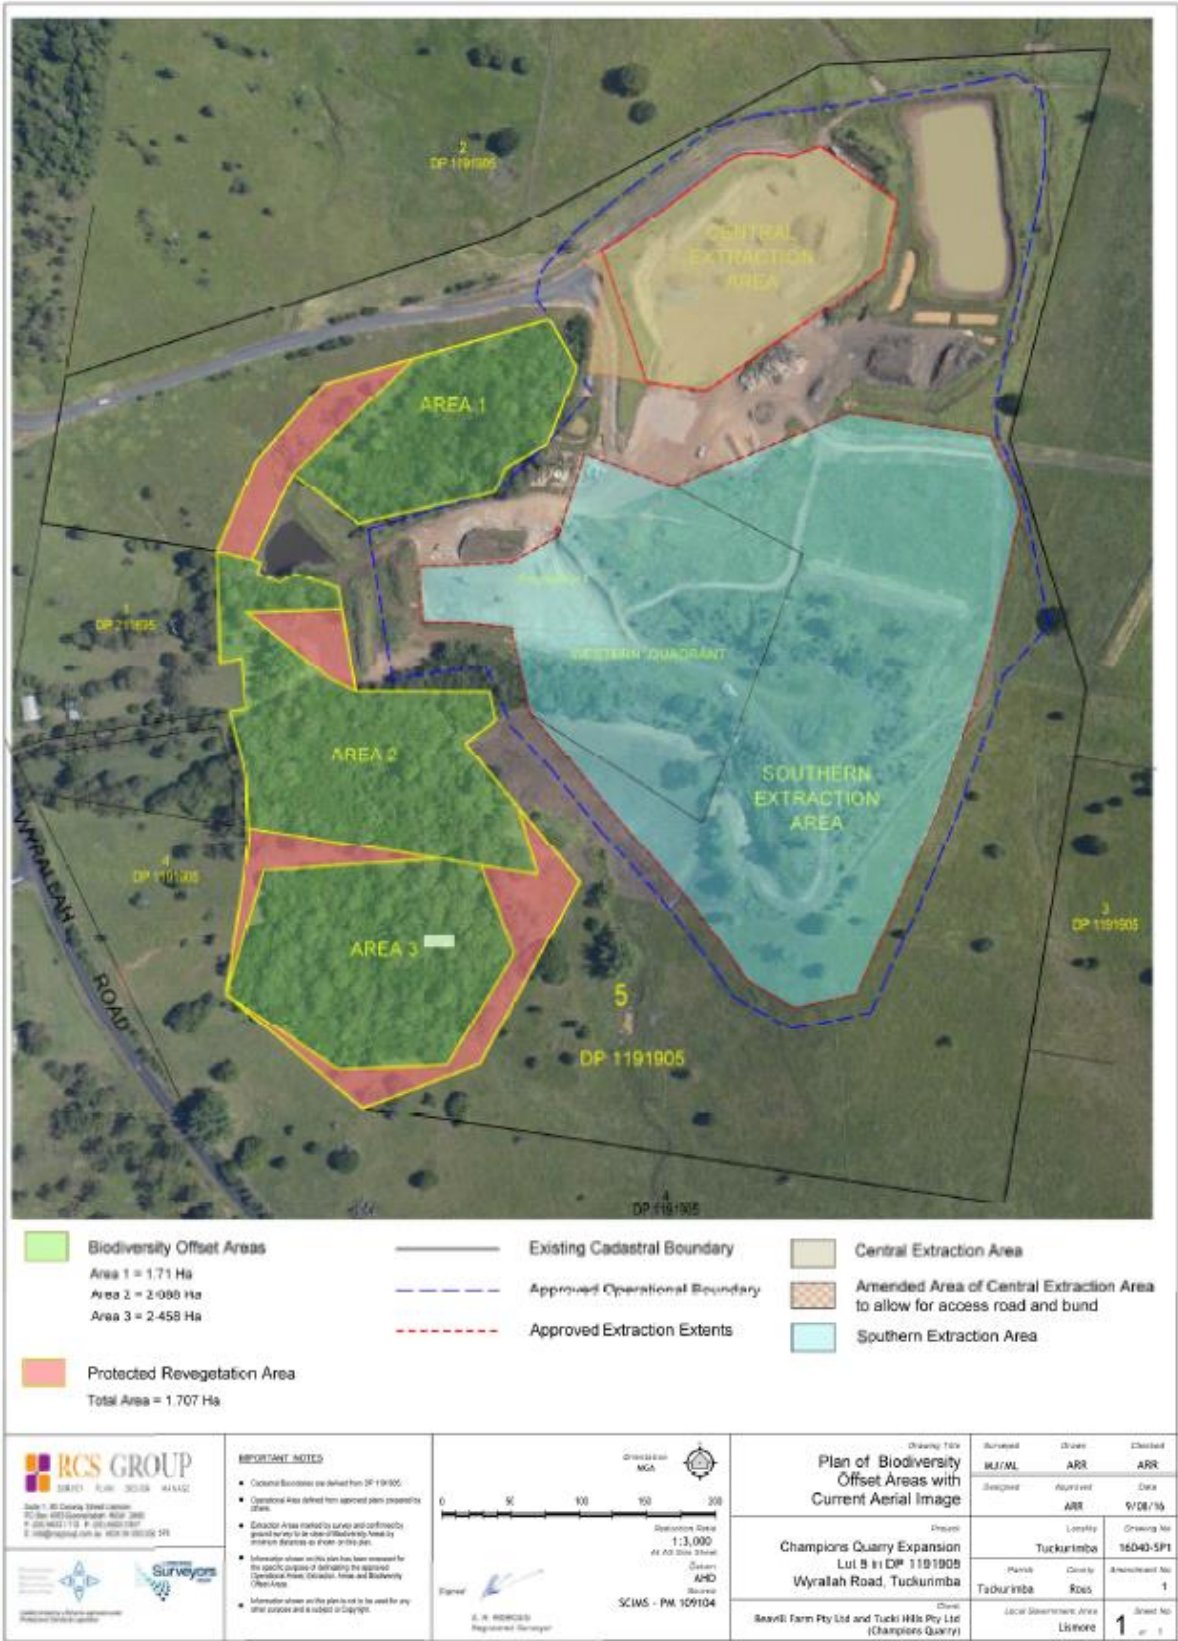
Figure 2: Project Layout (extract from Appendix 6 of Project Approval 09_0080)

The project layout, showing the following is provided as Figure 2 of Appendix A. The project layout includes:

Heritage management conditions are covered under Conditions 34, 35 and 36 of Project Approval 09_0080. Site activities are operated within the operational footprint shown in Figure 2 in Appendix A. No Aboriginal or non-aboriginal heritage items were detected onsite in 2024. Previous cultural heritage investigations on-site have not detected any Aboriginal or non-aboriginals heritage items in the area. Table 11 below provides a summary of the heritage conditions and their implementation to date.

The Biodiversity Offsets requirements are detailed in the Landscape Management Plan, with the location of the offset areas provided in Figure 2 in Appendix A.

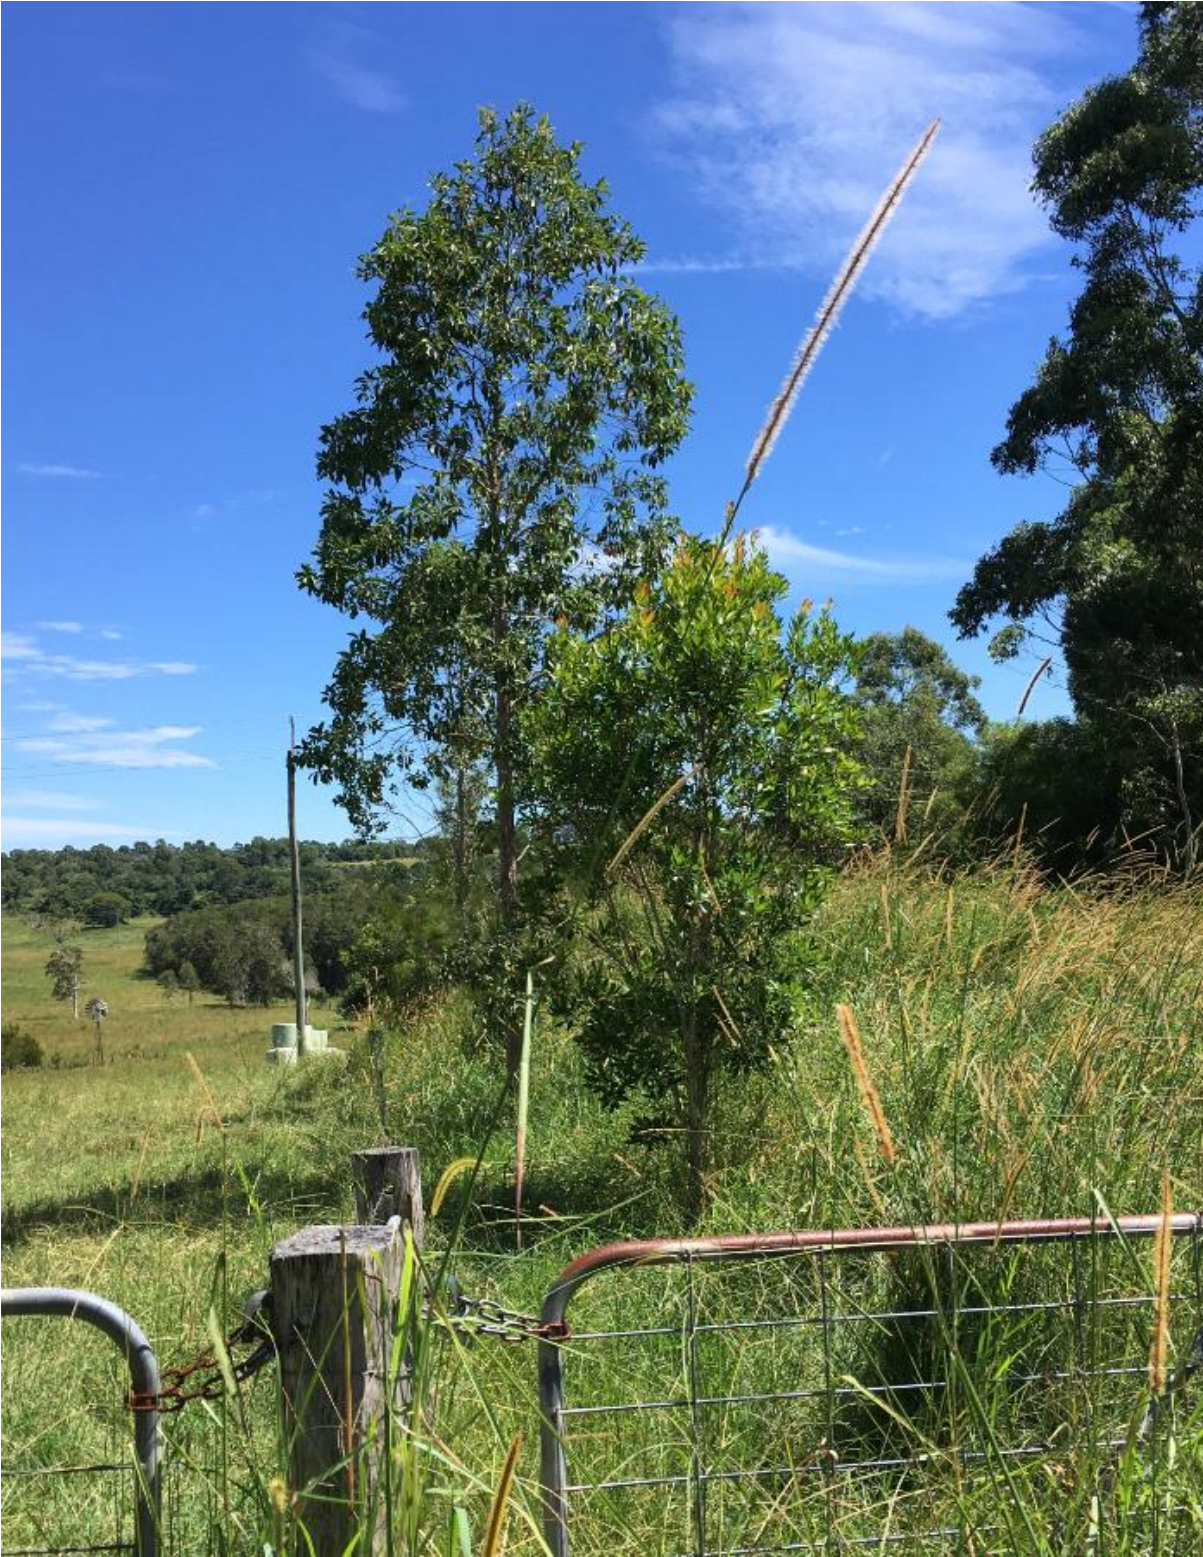
BUND A

View of Bund A from the eastern end, trees planted to the north of the Bund and a single row of non-koala habitat trees on the south-western side of the Bund. Photo March 2021.

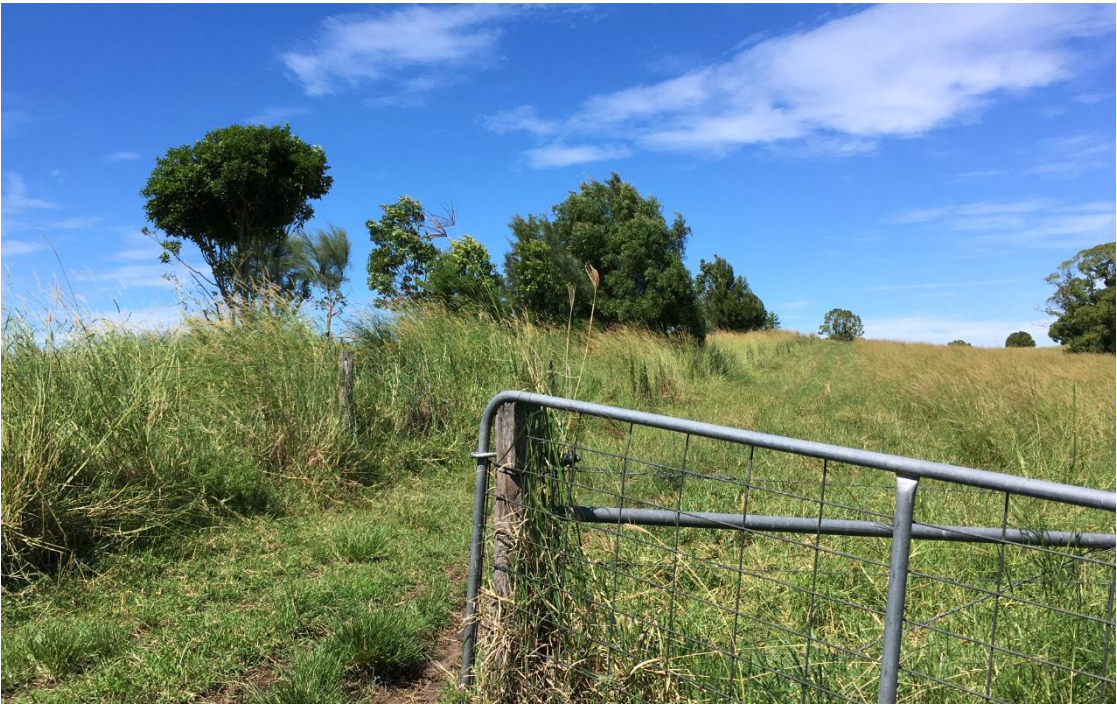
BUND B

Bund B – Low earth mound 10 metres wide. Established and grassed and planted with 2 rows of non-koala habitat trees/shrubs. Photo March 2021.

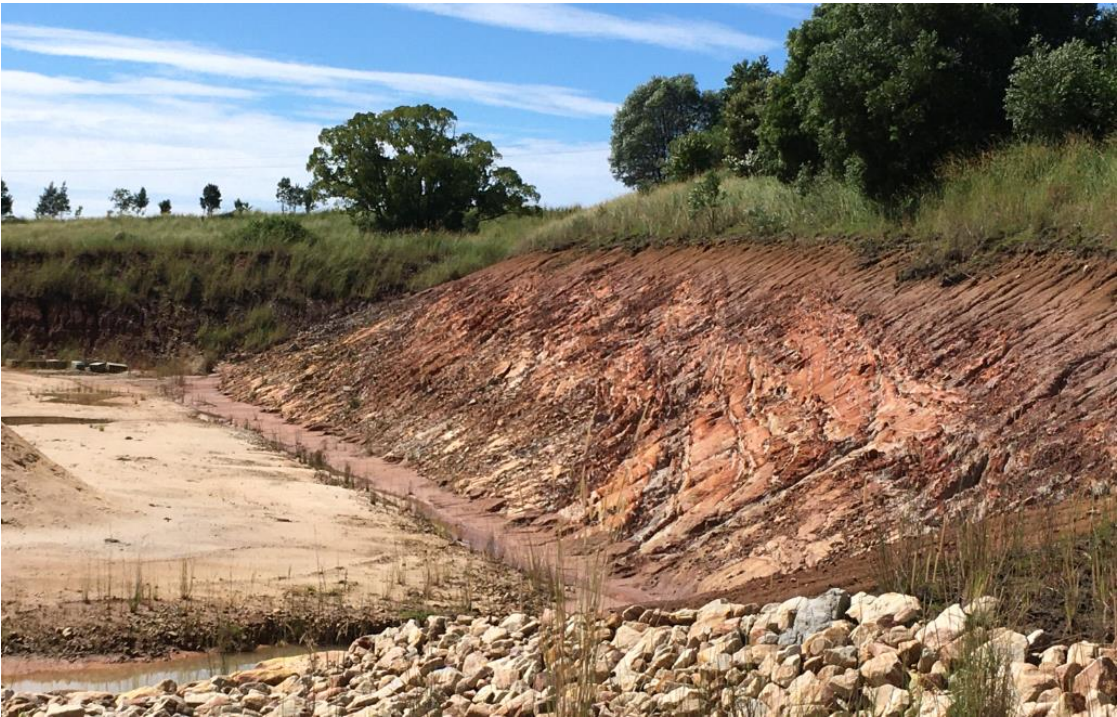
BUND C

Earth bund surrounding the Sand Washing Plant approx. 15 metres wide. Photo March 2020.

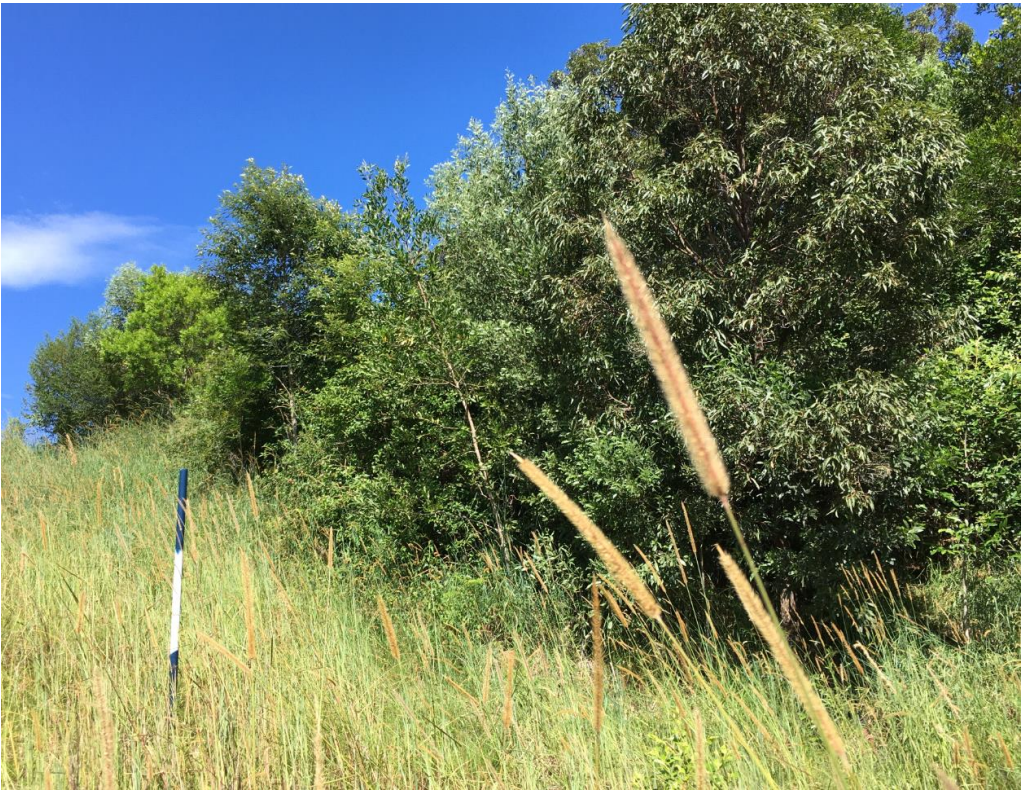
BUND D

10 metre wide bund. Established and grassed. Photo March 2021.

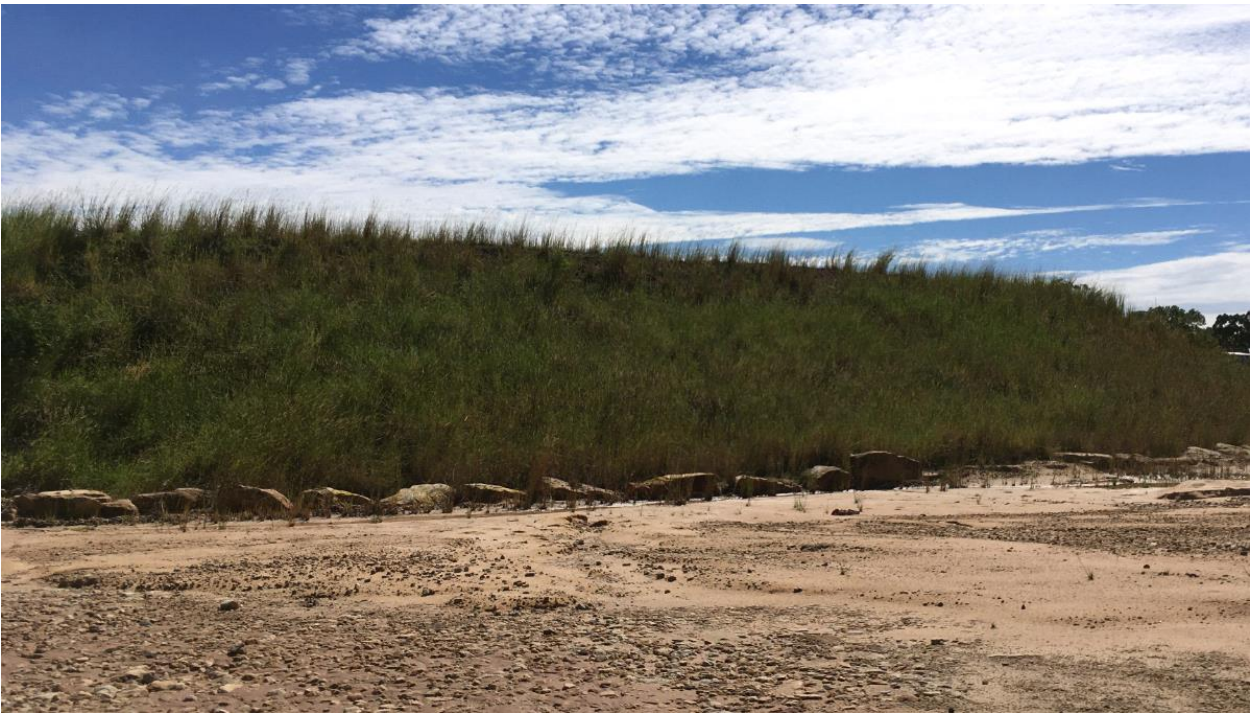
BUND E

Low sacrificial bund 10 metres wide. Established and grassed. Photo March 2021.

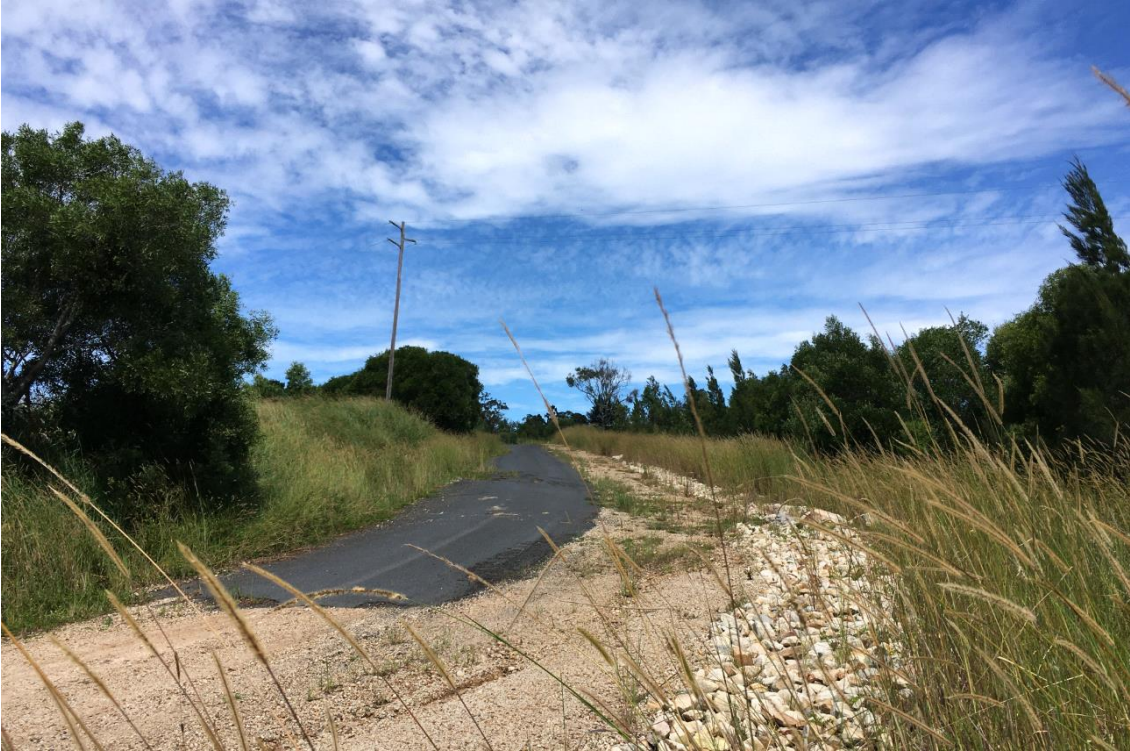
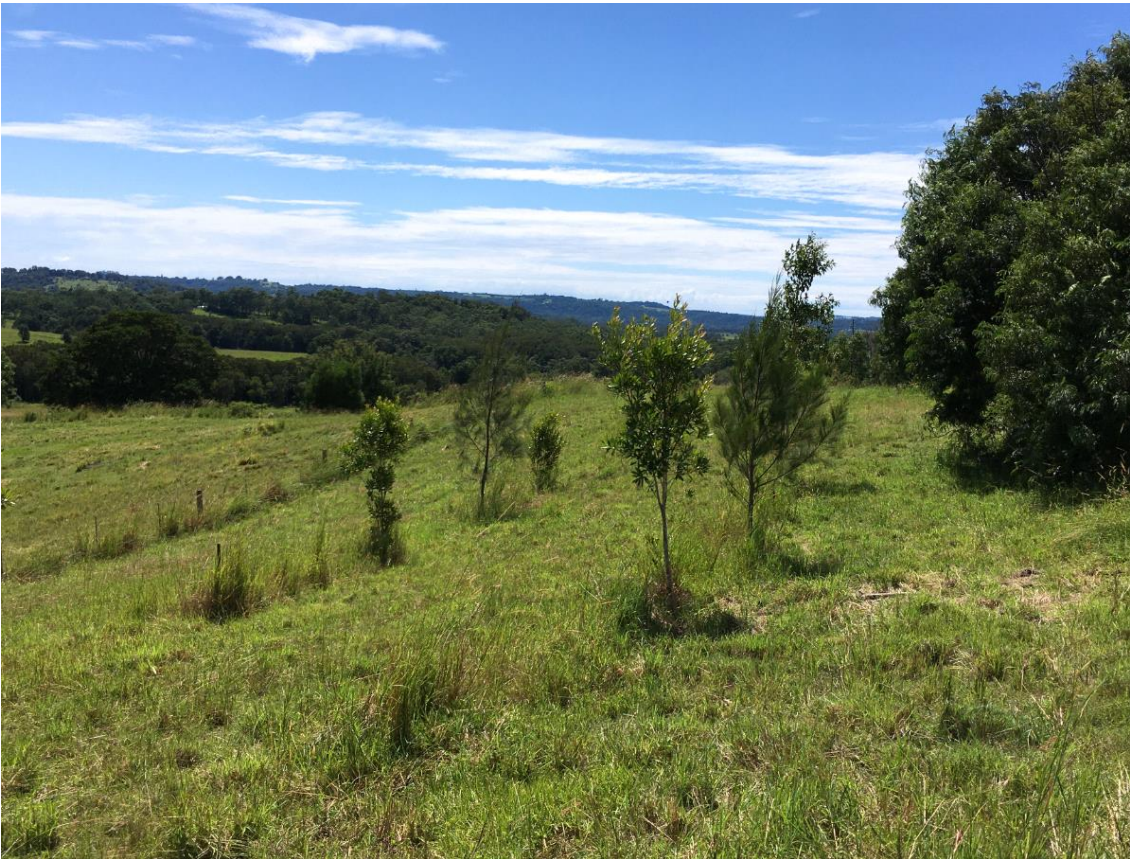
AREA TO THE NORTH OF THE MAIN ACCESS ROAD

Established, grassed and planted with 2 rows of non-koala habitat trees/shrubs. Photo March 2021.
